# Improved Materials For High-Temperature Black Liquor Gasification

James R. Keiser\*, J. Peter Gorog\*\*, Roberta A. Peascoe\*,  
James G. Hemrick\*, and Camden R. Hubbard\*

\*Oak Ridge National Laboratory, Oak Ridge, TN

# History Of Commercial Black Liquor Gasifier Constructed At Mill In New Bern, NC

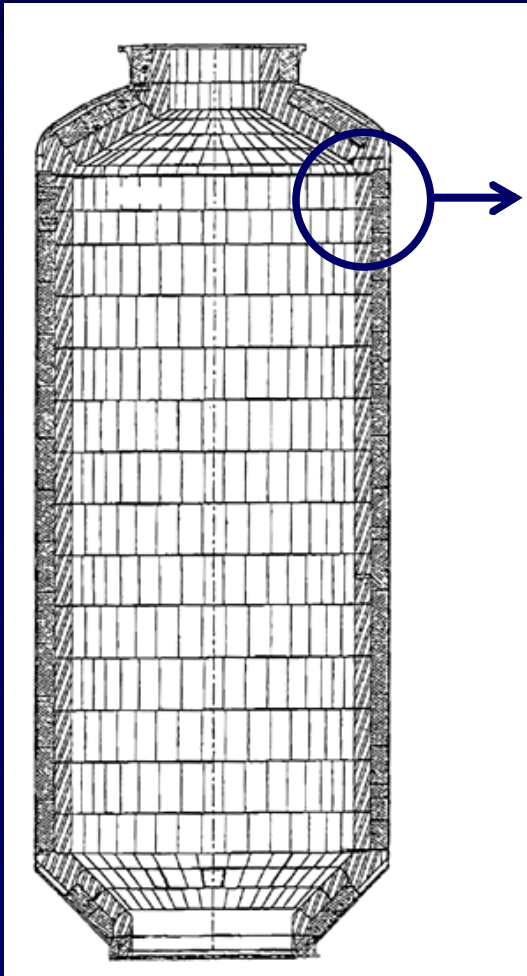
# Original Fused Cast Alumina Lining Replaced The 60% Alumina Brick That Degraded Rapidly

⇒ **150mm (~6")  $\alpha+\beta$  fused cast alumina**

⇒ **1/64" mica sheet**

⇒ **150mm (~6")  $\beta$  fused cast alumina**

⇒ **2x1/64" mica sheet**

⇒ **3/8" fiber blanket**

⇒ **1/8" insulating board**

⇒ **3/8" 316L Stainless Steel**

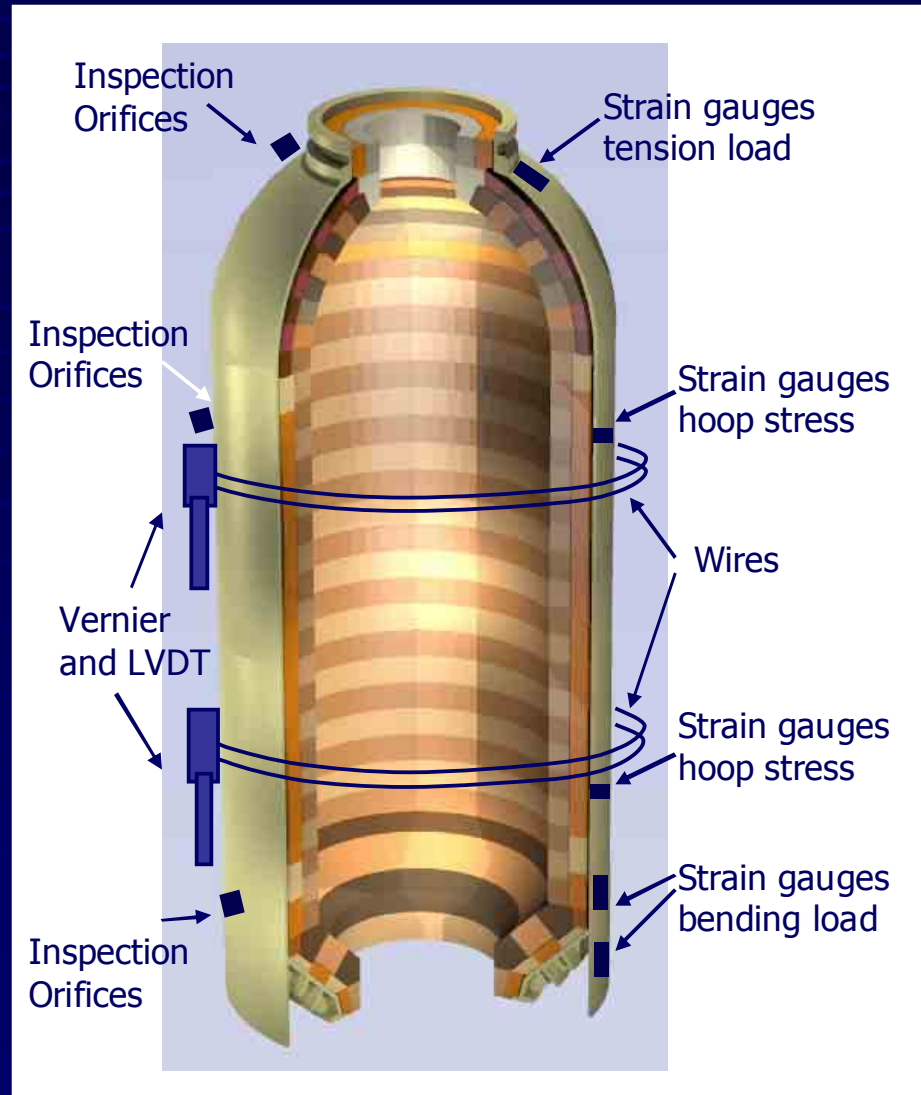
- ❖ Strain gauges mounted at two elevations on the barrel, in the bottom cone and at the top of the dome
- ❖ Wires with Vernier scales and LVDTs mounted on two elevations on the barrel
- ❖ Inspection orifices (with plugs) on the barrel and dome

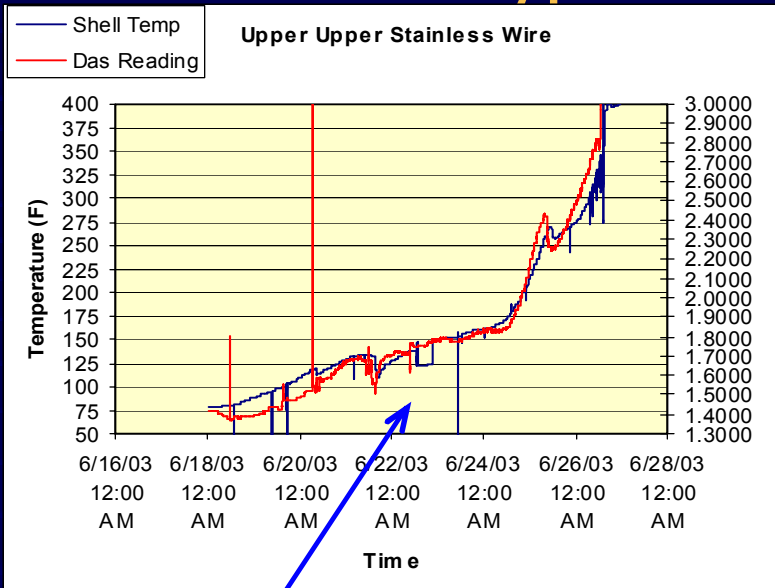
LVDT data tracked well with shell temperature at startup

Effect of shell loading can be seen

Day time - night time temperature variations

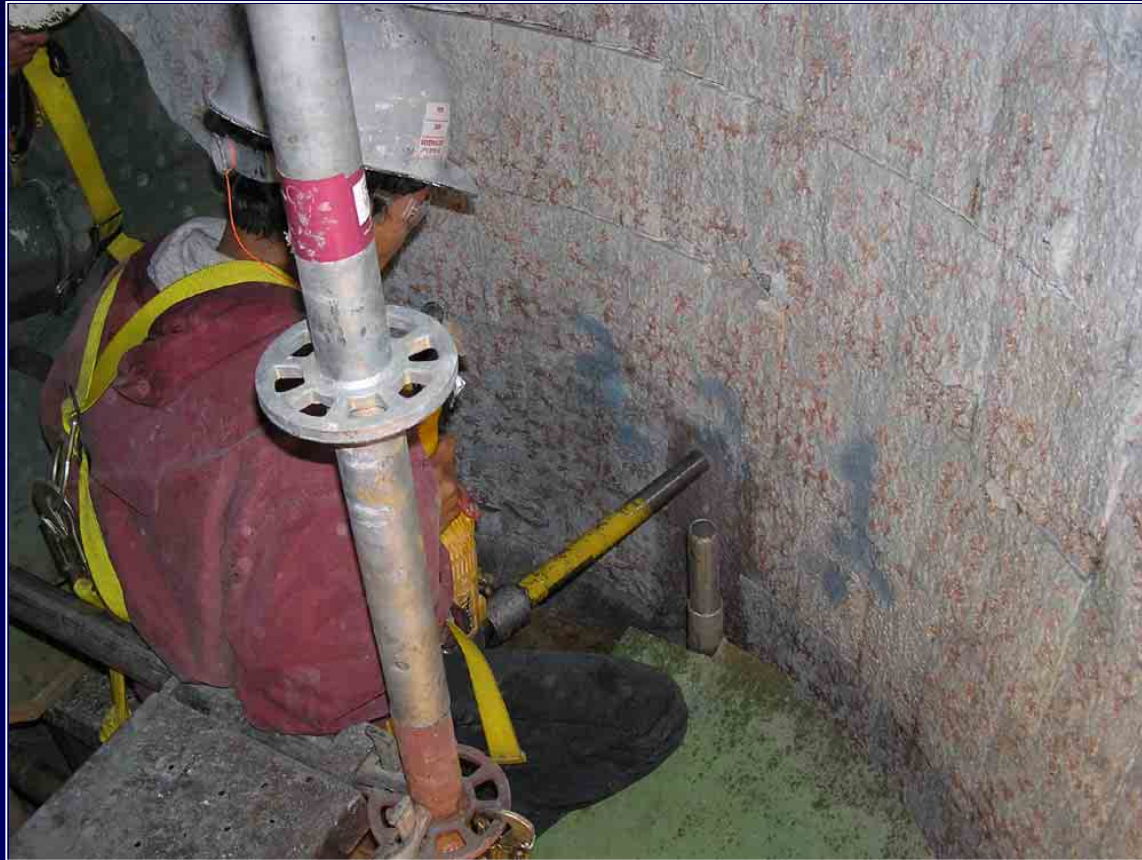
Core drilling was done with kerosene instead of water as the lubricant/coolant to avoid dissolving water-soluble corrosion products.

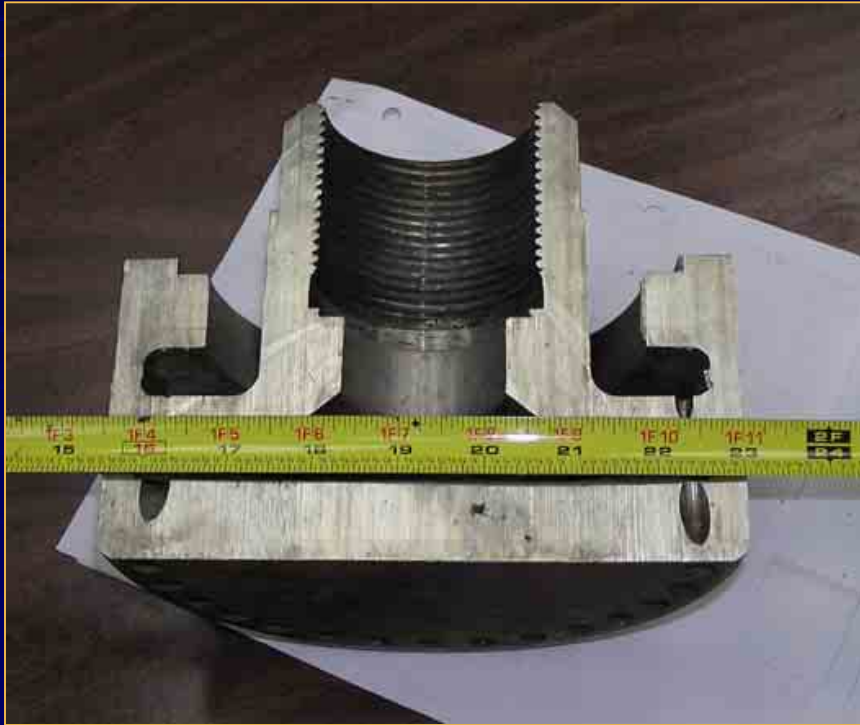
Cross section of black liquor nozzle

# Current Black Liquor Injection Nozzle Mixes Steam And Liquor But Exit End Of Holes In Nozzle Suffer Significant Wastage
